# Technical Bulletin

## Gray PIB Migration

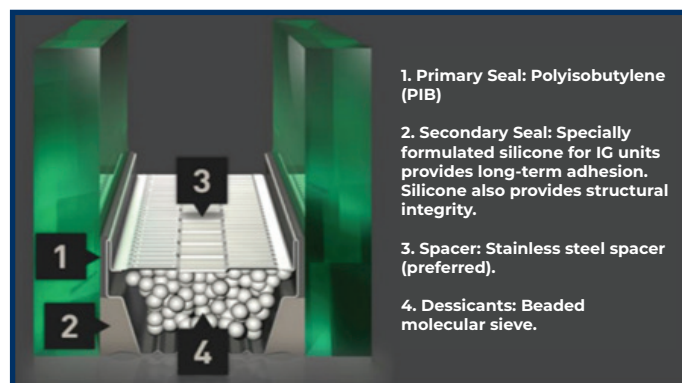
The litigation has centered on the visible “drip” or “movement” of gray PIB within the airspace, which is visually objectionable, and many times can cause the overall failure of the unit. The PIB movement may occur so slowly over time that the issue will not be apparent until the insulated glass unit has left production and has been installed. Since the PIB is contained inside the insulated glass unit, it cannot be cleaned and therefore must be replaced.

We recommend that all projects that specify a gray PIB be addressed for these issues with the glass fabricator. We hope that you find this information useful and a tool for avoiding this concern.

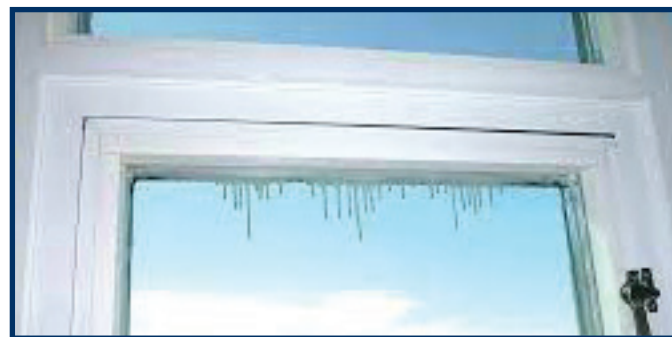
Elstner (WJE) Associates, the problems associated with PIB can result solely or primarily from normal exposure to sunlight, UV radiation, and/or heat. WJE also observed that the problems with PIB have occurred in only gray colored PIB.

It has been theorized that if the gray PIB adhesive is formulated improperly and the proper amount of UV stabilizer has not been provided, it could be the cause of this failure. Carbon black is a common UV stabilizer, so in sufficient quantities it maintains the stability of the PIB. The gray PIB is thought to require an additional stabilizer as the formulation has too low of a concentration to be an effective UV stabilizer on its own.
